NATIONAL PROGRAM FOR INSPECTION OF NON-FEDERAL DAMS
RUSSELL MILL POND (MA.) (U) CORPS OF ENGINEERS WALTHAM
MA NEW ENGLAND DIV MAR 80

MERRIMACK RIVER BASIN
CHELMSFORD, MASSACHUSETTS

RUSSELL MILL POND
MA 01219

PHASE I INSPECTION REPORT
NATIONAL DAM INSPECTION PROGRAM

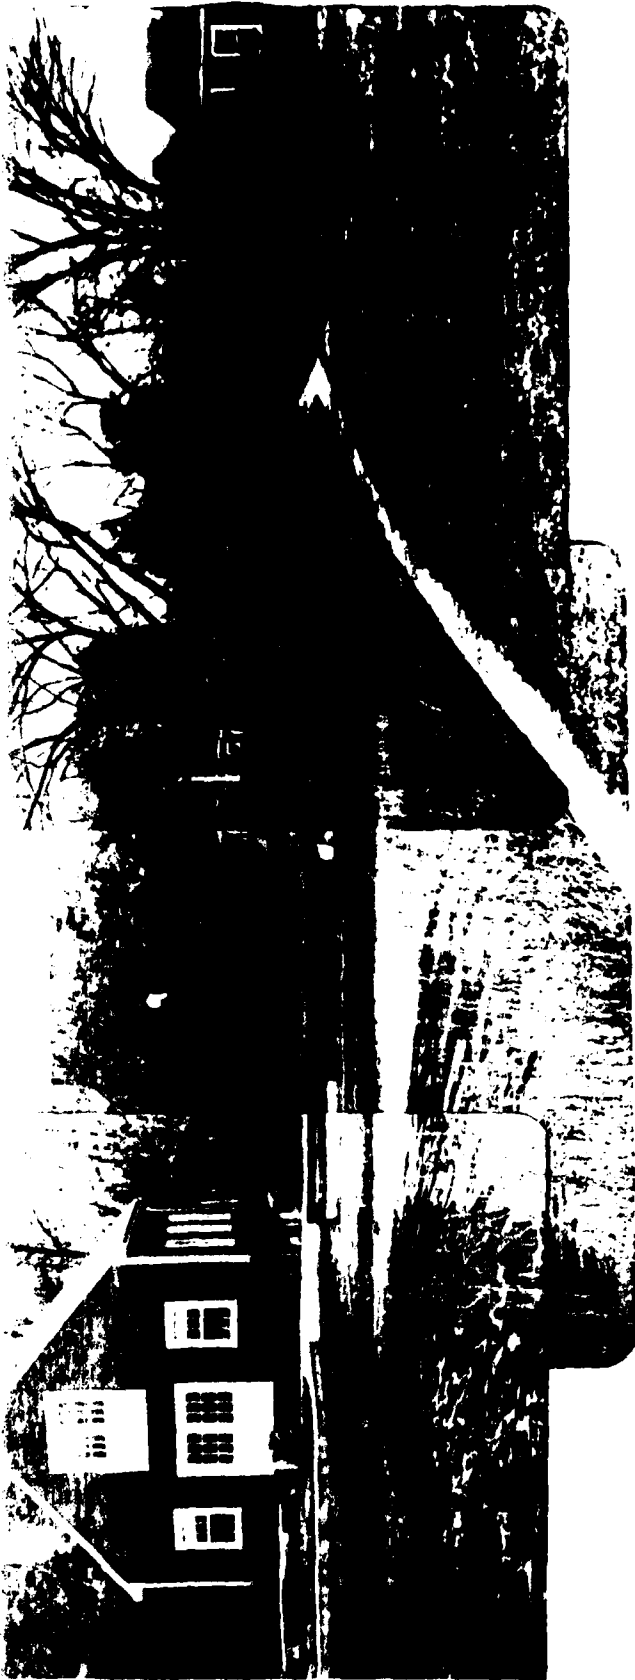
PHOTO NO. 1 - View of upstream face of Dam. Shown are the spillway, the 3 x 6 foot sluiceway below the small wood shed at the far left of the spillway, and the 4 foot pipe sluiceway to the right of the spillway, below the wood deck area. Beyond the spillway is the outlet channel area of Photo No. 3.

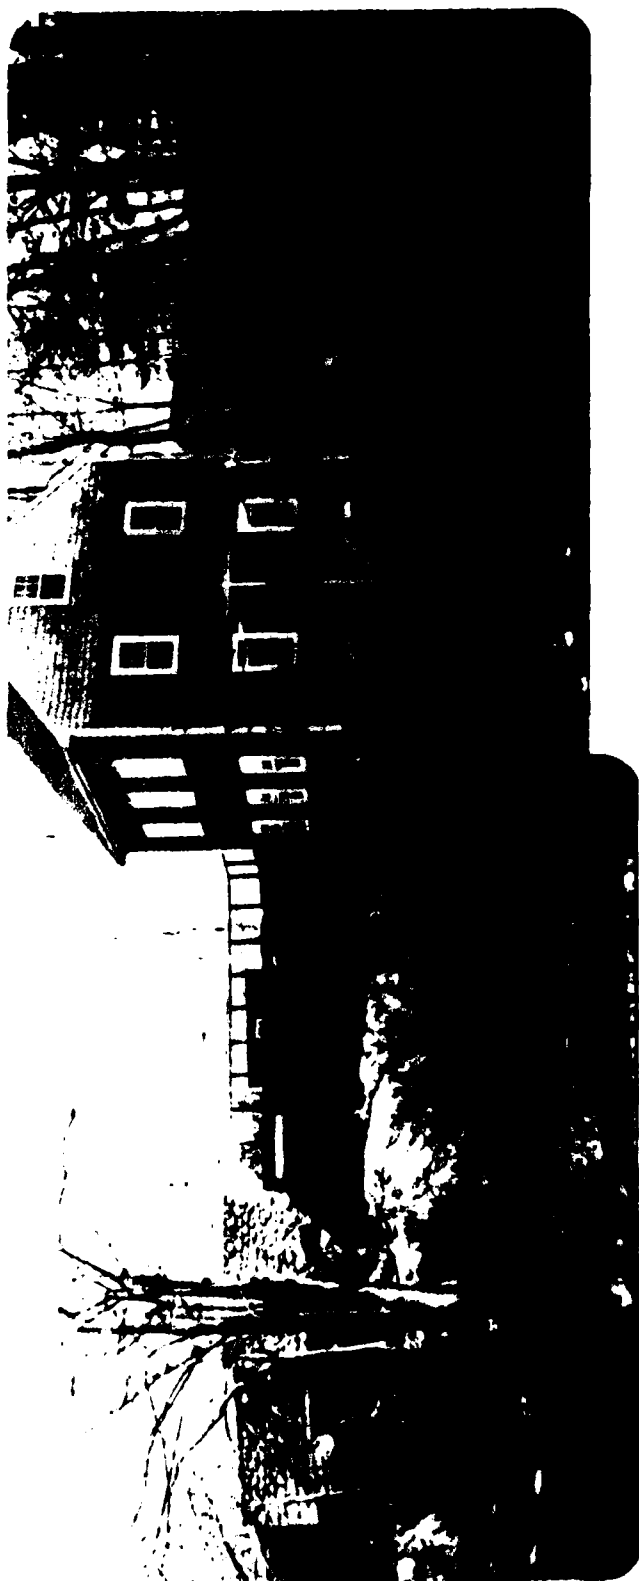
The dam consists of 1) hand-placed stone ranging in size from boulders to cobbles (not mortared), 2) cut stone blocks (not mortared), 3) rounded cobbles (mortared), and 4) concrete. The dam is about 120 feet in length and about 11 feet high. The dam has outlet sluiceways next to the right and left abutments and has a spillway adjacent to the right sluiceway. The foundation material of the dam is unknown. However, rock outcrops next to the downstream face of the dam indicate that the dam may rest on bedrock, photographs 2 and 9.

PHOTO NO. 2 - View of downstream face of Dam. At the left is the 4 foot outlet pipe. The spillway is at the center area. The discharge channel from the 3 x 6 foot sluiceway outlet is on the right of the mill building. Much of the stone masonry Dam has been rebuilt, as evidence in this photo by the use of granite slabs at the 4 foot outlet pipe.

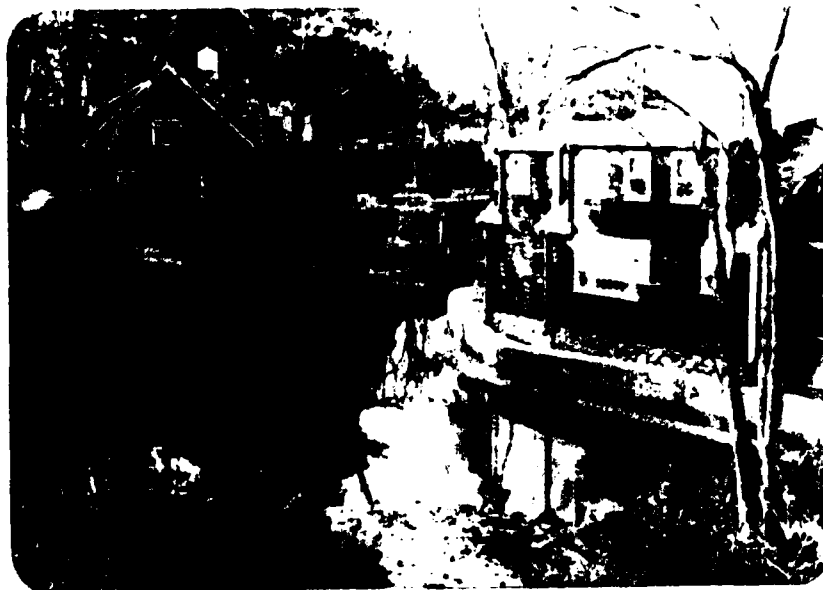
No significant obstructions were observed in the downstream channel, photograph 3.

The dam failure discharge is 1,230 \pm cfs. This assumes 40 percent of the 50 foot long, 11 foot high dam along the natural streambed fails. The downstream channel is narrow, constricted and "flat". See photographs 3, 7 and 8. The Mill Road culvert, about 200 \pm feet downstream and the flat swamp beyond, will cause a flow restriction. The flow of 260 cfs just prior to dam failure will flood the downstream channel and overtop Mill Road by about two feet.

PHOTO NO. 3 - Outlet channel area immediately downstream of the Dam.

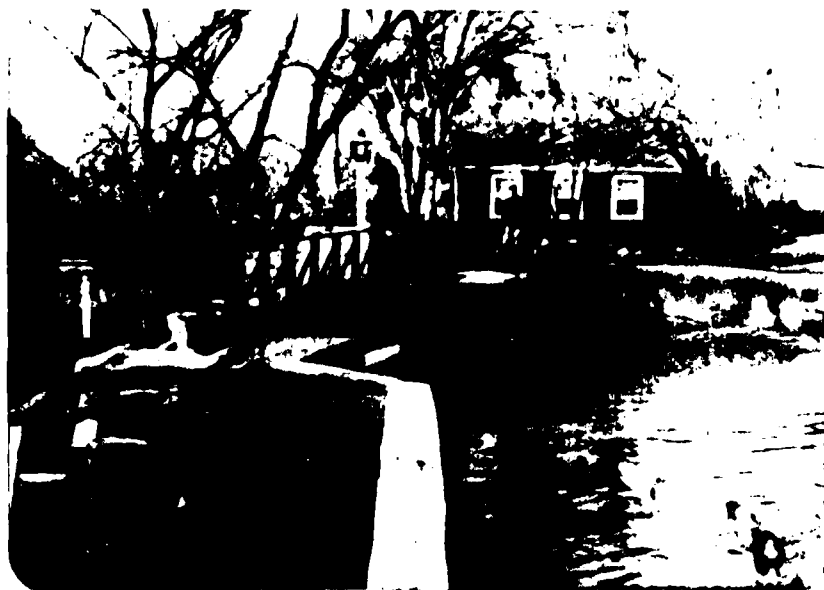
The visible portion of the concrete wall forming the upstream face of the dam is in good condition. Brush growth was observed next to the upstream face between the spillway and right outlet works, photograph 4.

PHOTO NO. 4 - This view shows the upstream face of the spillway and the location of the 4 foot pipe in Photo No. 5. Flashboards are in place at the spillway, which vary in height. Much of the pond is silted-in, as evidenced by the growth of weeds at the spillway.

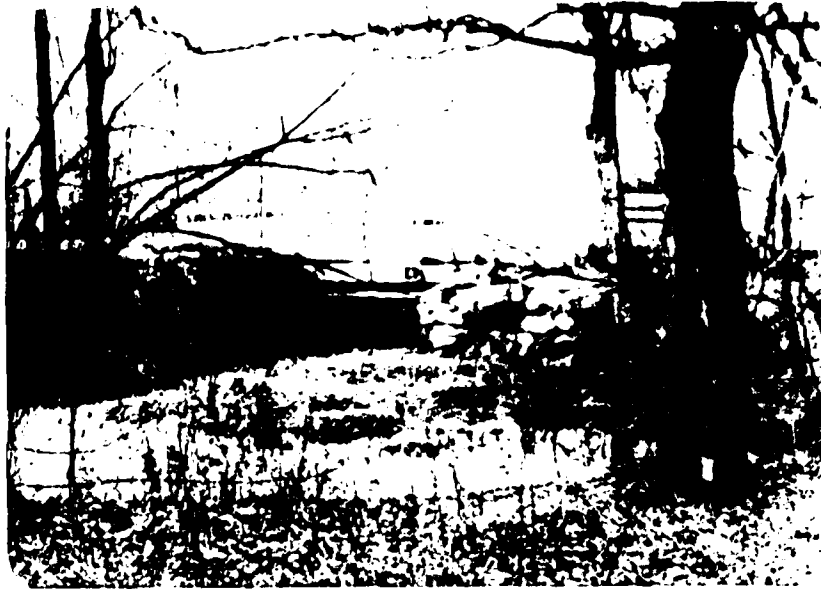
PHOTO NO. 7 - The Mill Road Bridge over Meadow Brook is shown here. Flow through the culvert opening is restricted by the downstream water level and an 8 inch gas main which blocks part of the opening.

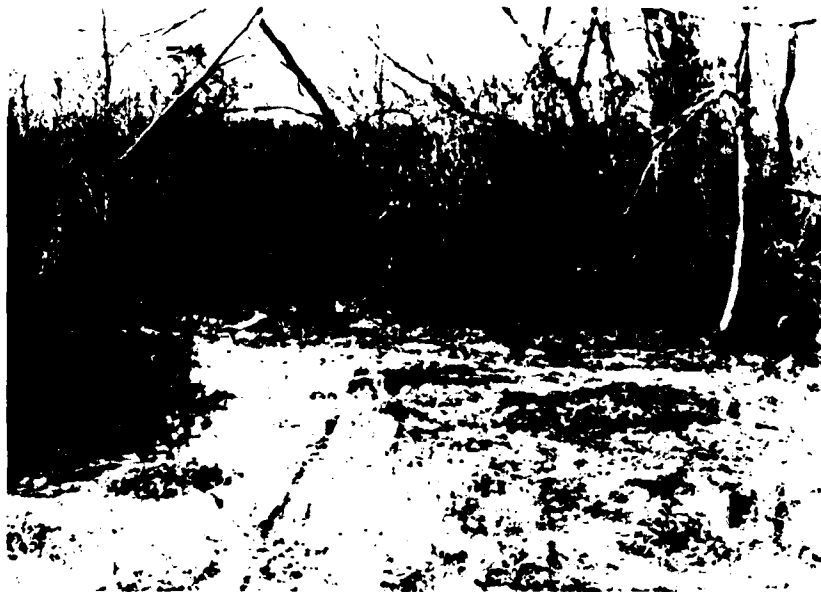
PHOTO NO. 8 - This view shows the downstream channel just past Mill Road. This photo shows typical channel conditions that exist for over 2½ miles. The water surface level is controlled by a cranberry bog 3,000 feet downstream.

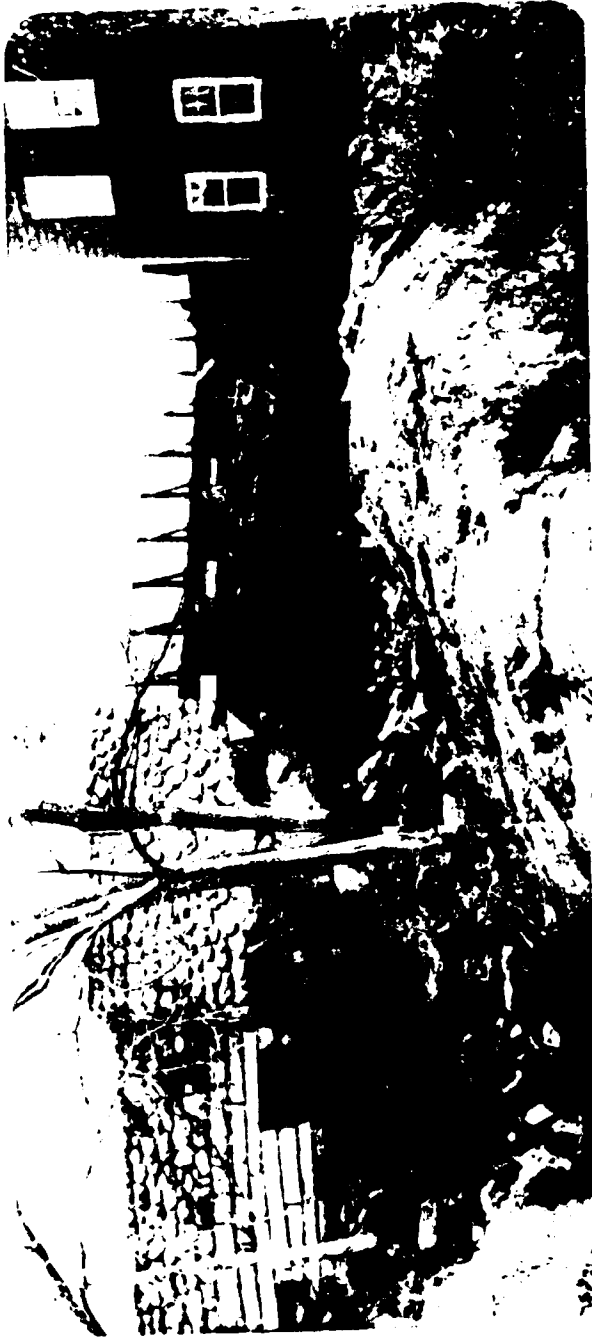
The crest of the dam is in good condition, photograph 9. No evidence of cracking or misalignment of the crest that could be attributed to movement of the dam was observed.

No seepage was observed through the stonework on the downstream side of the dam below the spillway section. A crack in the transverse direction was observed in the concrete floor of the spillway. A small void was observed beneath the concrete floor near the transverse crack and was apparently caused by erosion. The discharge channel of the spillway and right sluiceway consists of bedrock and cobbles, photograph 9.

PHOTO NO. 9 - Panoramic view of the downstream face of the Dam from the right
abutment to the left end of the spillway.

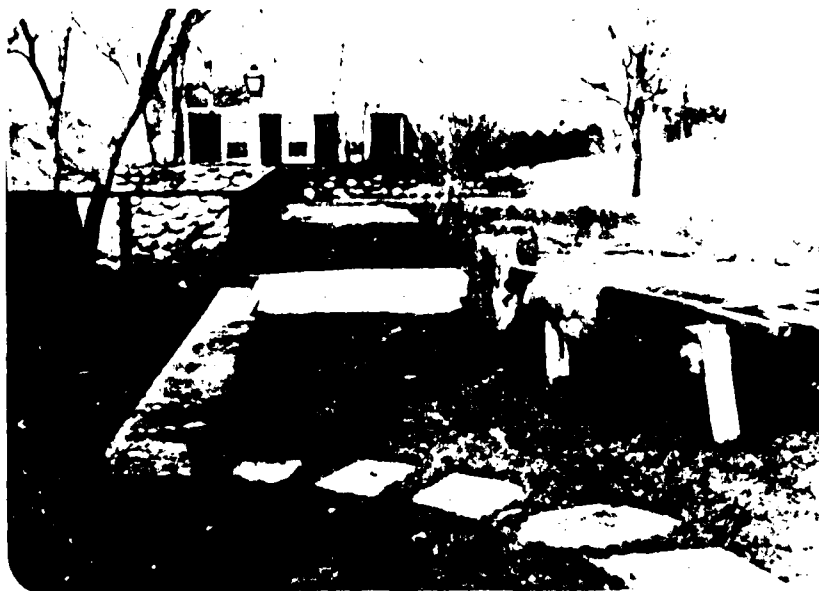
PHOTO NO. 14 - Crest of Dam as viewed from the left
outlet structure.
